HomeInfo, LLC

A Sample Report On The Conditions At:

123 Main Street
Anytown, Alabama 36101-1101

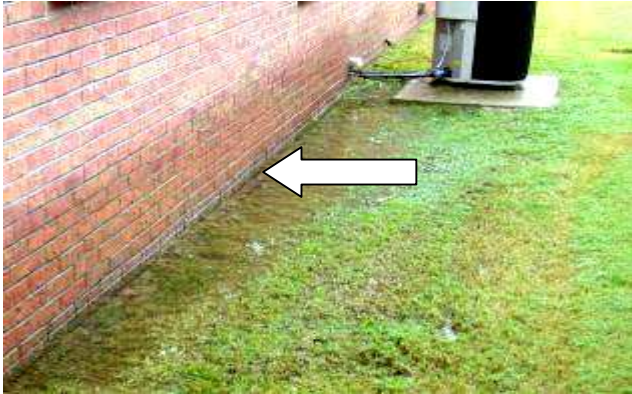
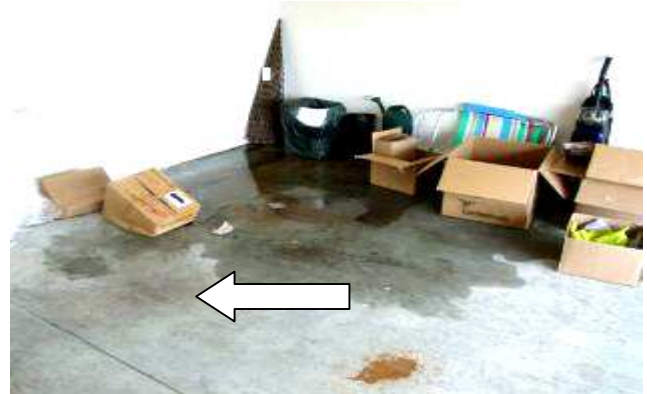
Needs Attention. The ground is not adequately sloped away from the foundation on the back left side. Generally accepted landscaping practices state that there should be 4 – 6 inches of slope away from the foundation within the first 10 feet. This condition has allowed water penetration into the garage. This can cause wood deterioration and could attract wood eating insects.

A view of water concentration around the back left exterior. A view of water penetration inside the garage.

Recommendation. A licensed landscape contractor should evaluate this condition and make any needed changes to divert water away from the back left side of the house.

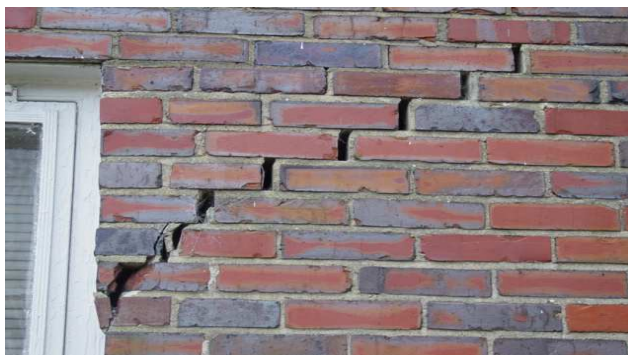
Needs Attention. The exterior is covered with brick siding. There are visible cracks & evidence of foundation movement on the right back side.

A view of diagonal cracks in the exterior brick wall.

Recommendation. A licensed structural engineer should further evaluate the condition of the foundation and make recommendations for repair.

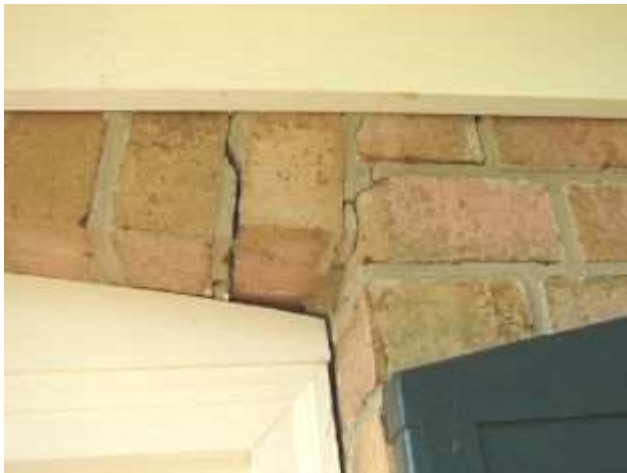
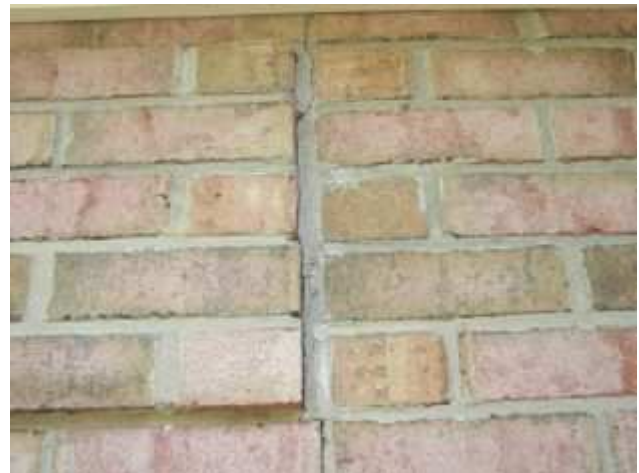
Note: There are small cracks in the brick on all four sides. I recommend the new owner monitor these cracks occasionally and if they change in width or length, a contractor who is experienced with foundation settlement should evaluate and make any needed repairs.

A view of small exterior settlement cracks along the front side.

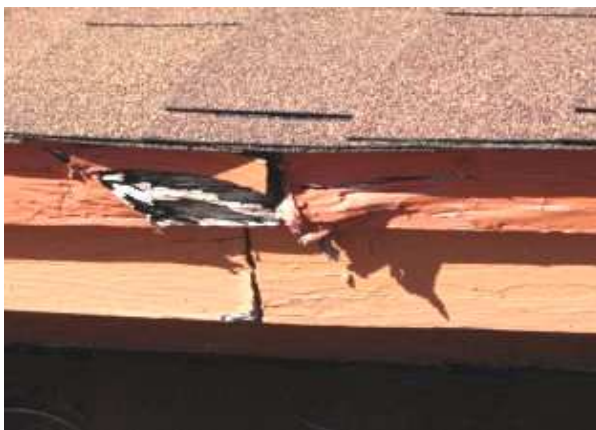
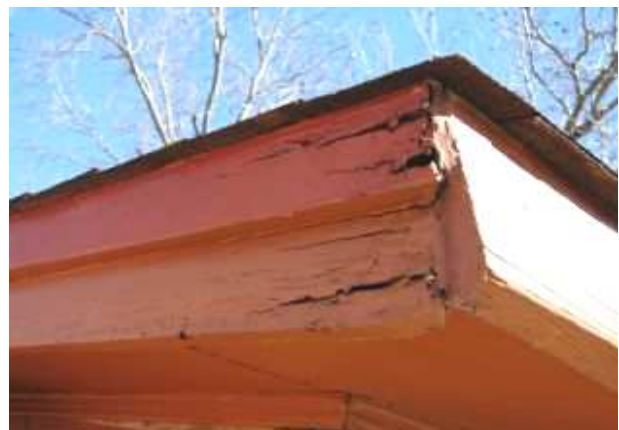
Needs Attention. The fascia board & soffit on the front of the house is deteriorated.

A view of deteriorated fascia board along the front side of the house.

Recommendation. A licensed contractor should replace this board and prime and paint the replacement board to match.

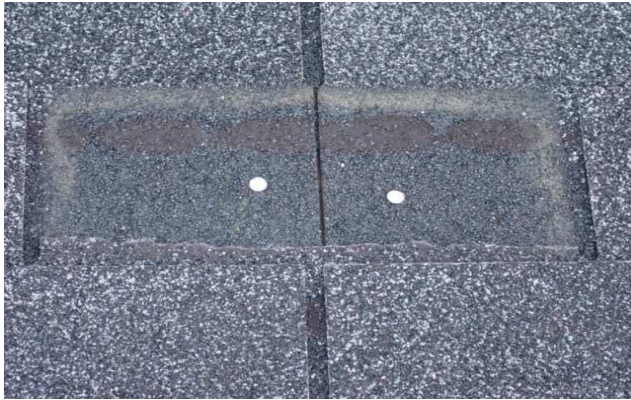
Needs Attention. There is one layer of asphalt shingles. One shingle tab is missing. There are numerous areas that show signs of hail damage. These conditions could lead to water penetration into the living area.

A view of a torn shingle tab.

Recommendation. A licensed roofing contractor should evaluate the condition of this roof and make the needed repairs.

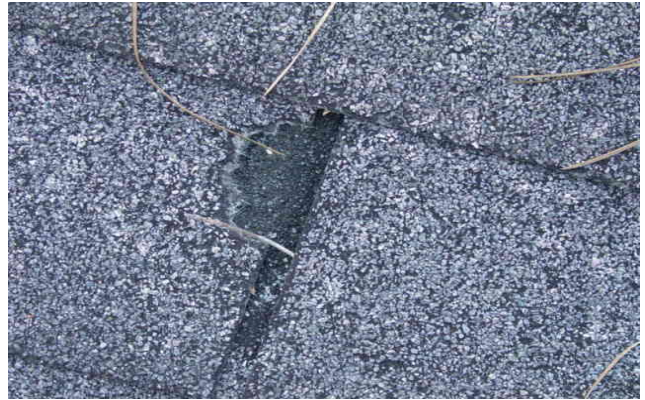
A view of hail damage.

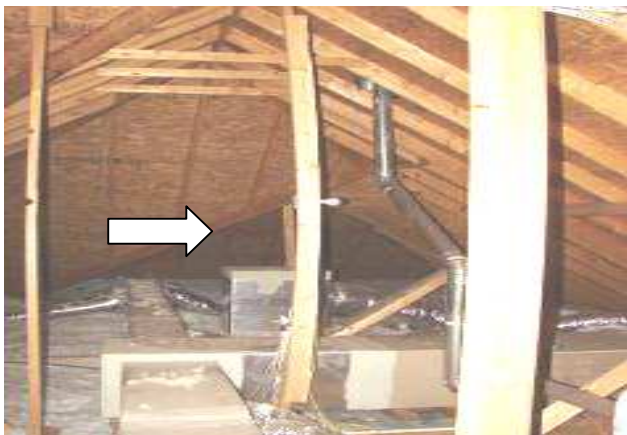
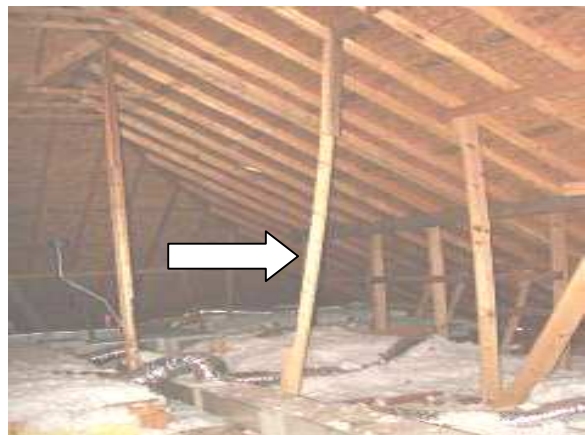
Needs Attention. There are center posts that are not supporting the center part of the roof. These posts are constructed of 2" x 4" lumber and are bowed from excessive weight. These posts should be overlapped or cross braced for added strength. Their present condition could allow the roof to sag.

A sample view of bent center post located inside the attic space.

Recommendation. I recommend a licensed contractor evaluate the condition of these center posts and make the necessary repairs to provide additional strength to these posts.

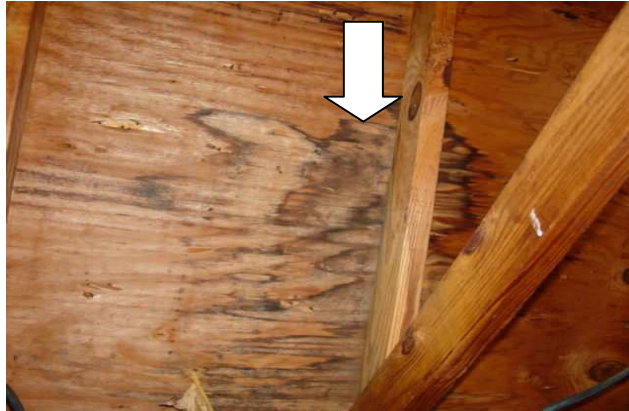
Needs Attention. The underside of the roof decking shows signs of water penetration. This condition could damage the roof deck and the ceiling below this area.

A view of moisture stains on the roof decking.

Recommendation. A licensed roofing contractor should evaluate the condition of the roof and make any needed repairs.

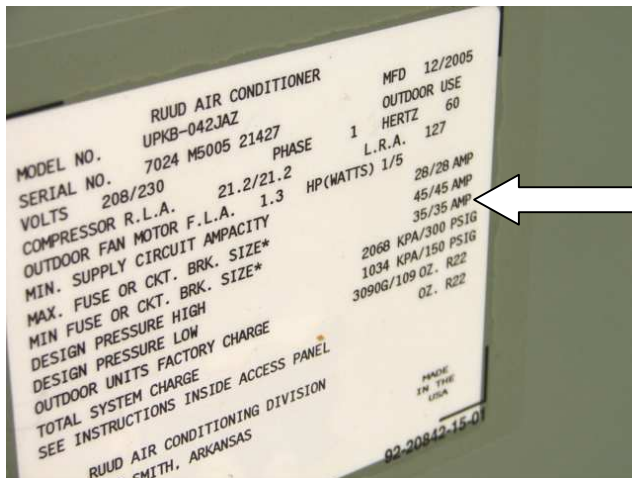
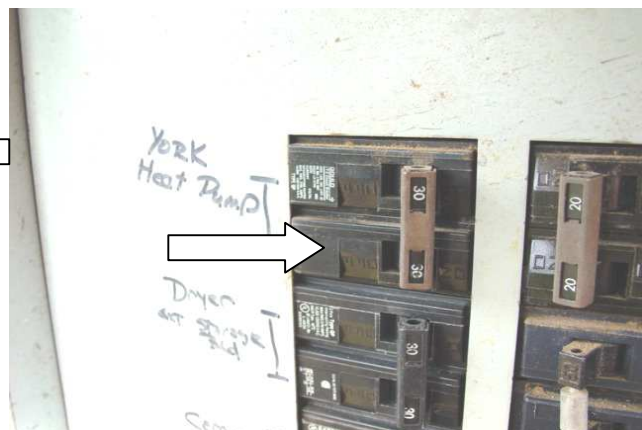
Needs Attention. The upstairs air conditioner breaker is undersized. The nameplate rating for this unit is a minimum of 35 amps. It contains a 30 amp breaker. This condition could lead to breaker failure and loss of air conditioning.

A view of the nameplate rating of 45 amps maximum. A view of the 30 amp breaker inside the breaker panel.

Recommendation. A licensed electrician should evaluate and replace the breakers with the proper sized breakers.

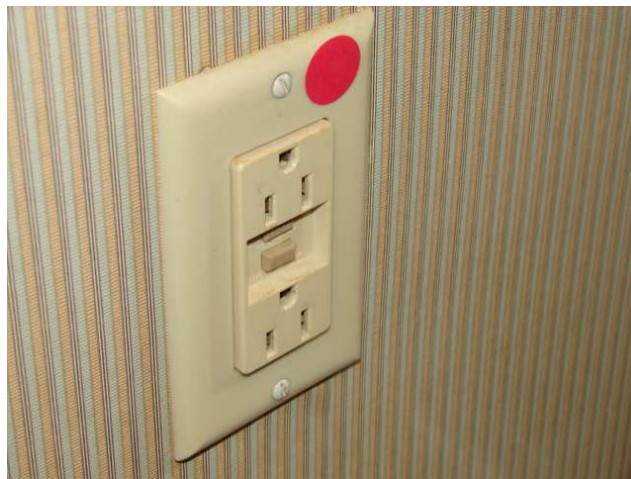
Needs Attention. There are no Ground Fault Current Interrupters (GFCI's) installed on the kitchen or exterior circuits. The hall bathroom GFCI does not trip under a test condition. This outlet has been marked with a red dot.

Concern. Ground Fault Current Interrupters (GFCI's) are designed to open the electrical circuit faster than conventional circuit breakers and should be used on all exterior circuits and other interior circuits that are within 4 feet of any cold water source. This is a personal safety hazard.

A sample view of a faulty GFCI.

Recommendation. GFCI's were not required at the time this house was originally built. However, I recommend the new owners consider hiring a licensed electrician to install GFCI outlets on those circuits that are near sinks & vanities and on all exterior circuits.

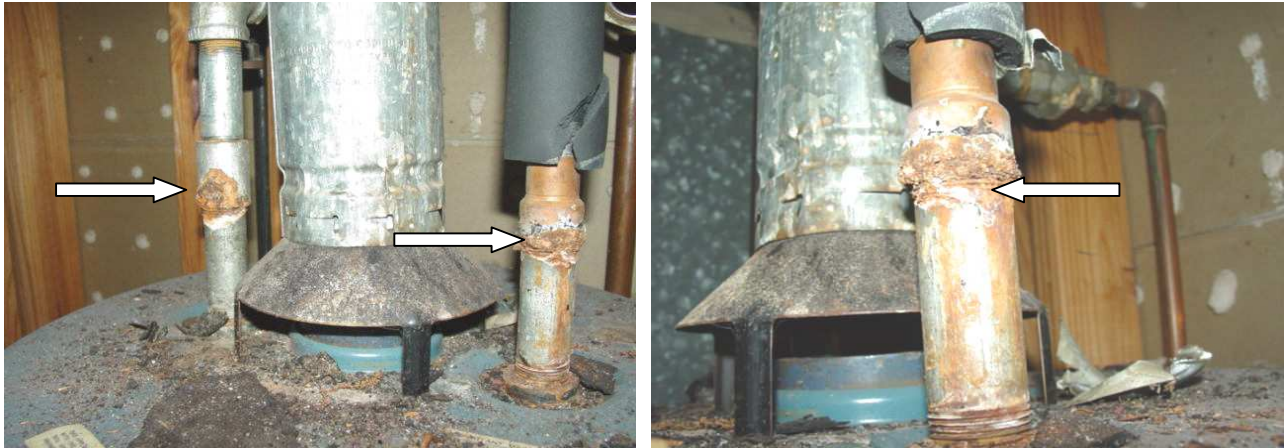
Needs Attention. A 40 gallon natural gas water heater is located in the hall closet. There are signs of supply pipe corrosion on top of the water tank.

A wide angle view and a close up view of the corroded water supply pipes.

Recommendation. A licensed plumber should evaluate the condition of the supply pipes and make the needed repairs.

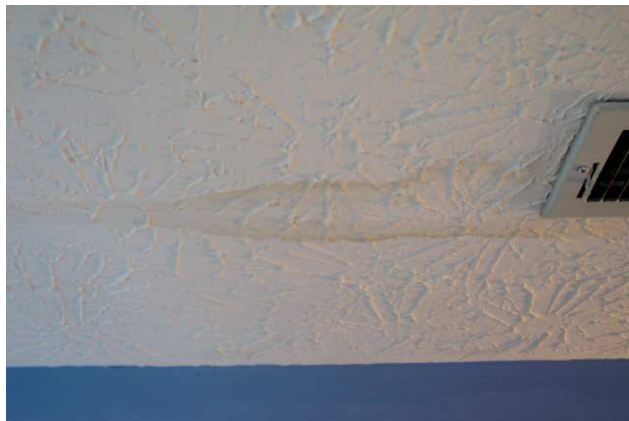
Needs Attention. The ceiling in the upstairs bathroom shows signs of water penetration.

A view of a ceiling stain in the upstairs bathroom.

Recommendation. A licensed roofing contractor should evaluate the condition of the roof and make any needed repairs.

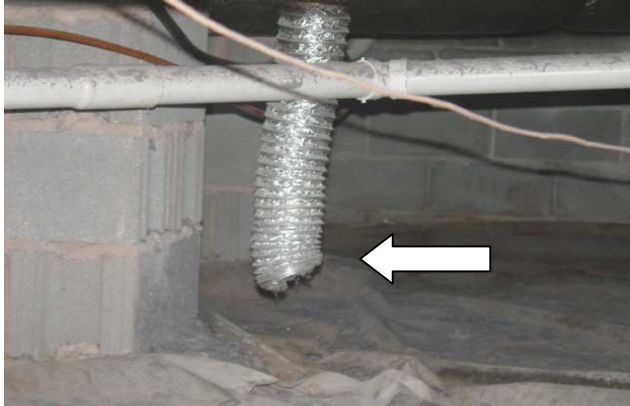
Needs Attention. The dryer is improperly vented. The vent pipe is terminated into the crawl space. The additional moisture can also cause mold growth inside the crawl space area and damage the floor joist. The lint accumulation could also create a fire hazard.

A view of a dryer vent terminated inside the crawl space.

Recommendation. A licensed contractor should terminate the dryer vent to the exterior of the home.

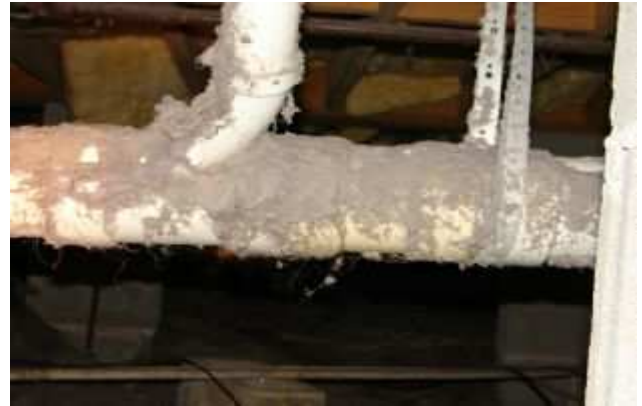
A view of lint build-up inside the crawl space.

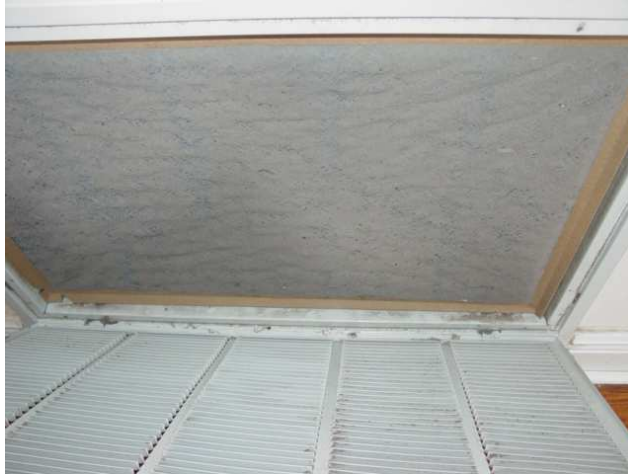
Needs Attention. The return air filters are clogged. This could adversely affect the indoor air quality and the efficiency of both systems.

A view of one of the clogged filters.

Recommendation. All return air filters should be changed monthly.

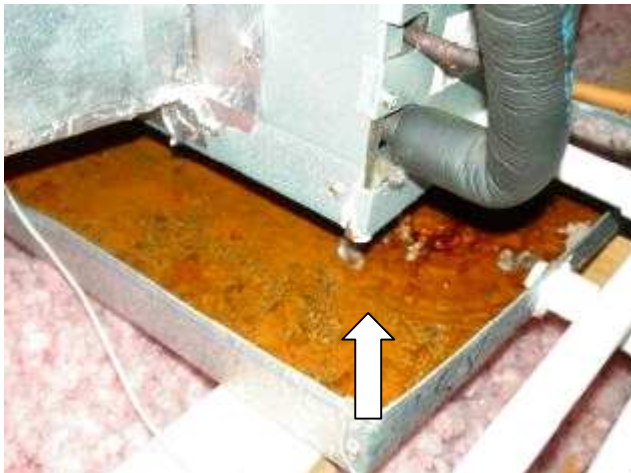
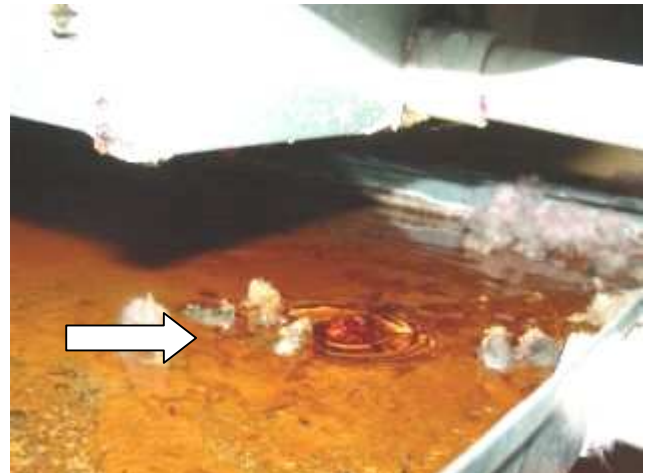
Needs Attention. The cooling coil for the A/C system is mounted inside the attic space. The auxiliary drain pan is approximately 1/2 full of water. This is an indication that the primary and the back-up drain lines are both stopped up. This condition could allow water to overflow the drain pan and damage the ceiling below.

A view of the auxiliary drain pan that is approximately half full of water.

Recommendation. I recommend a licensed HVAC technician evaluate this condition and make the needed repairs to unstop the drain lines. Consideration should be given to installing a drain pan float switch.

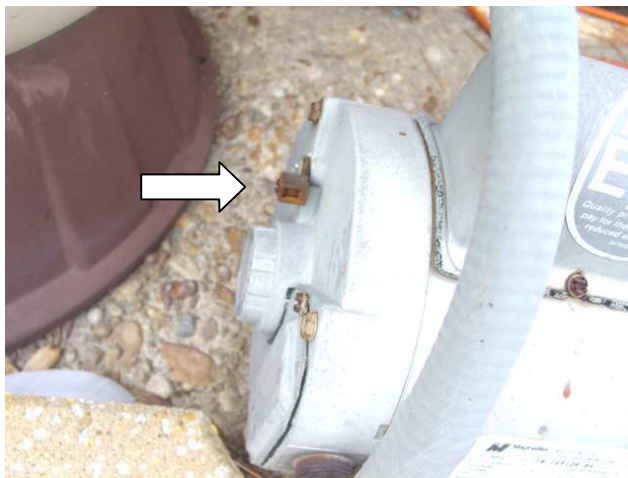
Needs Attention. There is no evidence of an electrical bonding conductor between the pool and the pool pump. All electrical components within the pool system should be bonded together to avoid a voltage differential between the pool pump and the pool. This could be a safety hazard.

A view of the missing bond wire from the bond clamp.

Recommendation. A licensed electrician should evaluate this condition and make the necessary repairs to bond the pool to the filter pump.
